## PROJECT STAR LOFTS ON THE BAY

### SERVICE ROOF REHABILITATION WITH SILICONE COATING

This case study details the roof repair project at Star Lofts on the Bay located in Miami, FL. The project aimed to extend the roof's life expectancy and enhance the building's overall structural integrity.

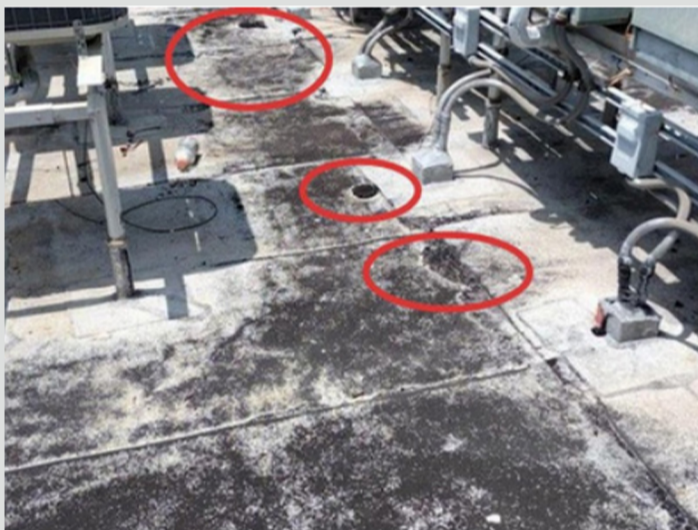
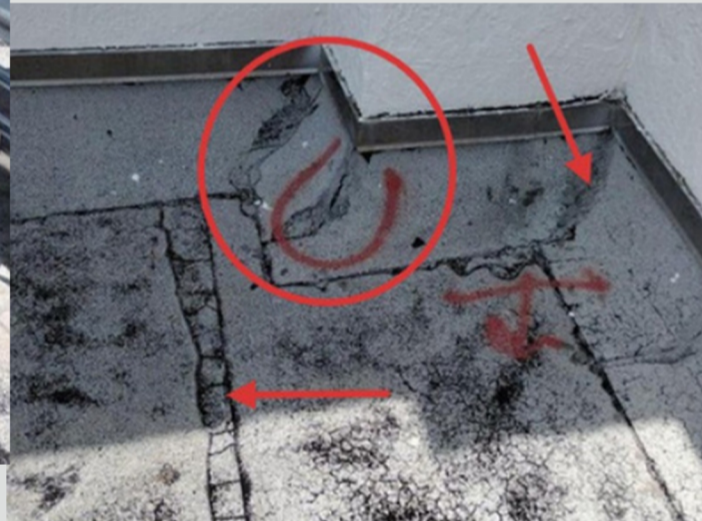
- A thorough inspection of the roof revealed several critical issues:
- Poor overall condition with widespread cracks, openings, and pattern growth, indicating the roof's life expectancy had passed.
  - Multiple areas with trapped debris and staining within the membrane.
  - Cracks and tears, especially in the corners, allowing water intrusion.
  - Large debris and moisture stains near the drainage areas, indicating improper water drainage.
  - Additional examples of cracks and tears across the roof surface.
  - The severity of these issues necessitated immediate repairs to prevent further water infiltration and potential structural damage.

- Preparing the roof by removing debris and cleaning the surface.
- Repairing identified cracks and tears with appropriate materials.
- Engaging with qualified contractors, such as Group LanDev, to ensure the highest standards of workmanship.
- Applying the silicone roof coating evenly across the entire roof surface.
- Ensuring proper drainage by cleaning and adjusting the drainage systems.
- Conducting a final inspection to ensure the quality and effectiveness of the repairs.
- Reapplication of the silicone coating as needed to maintain its protective properties.
